TEST REPORT

REPORT NO : 2008CB1484

Product : MTL Mushroom Bolt c/w Steel Bracket & Nut

TEST RESULTS : BREAKING LOAD TEST

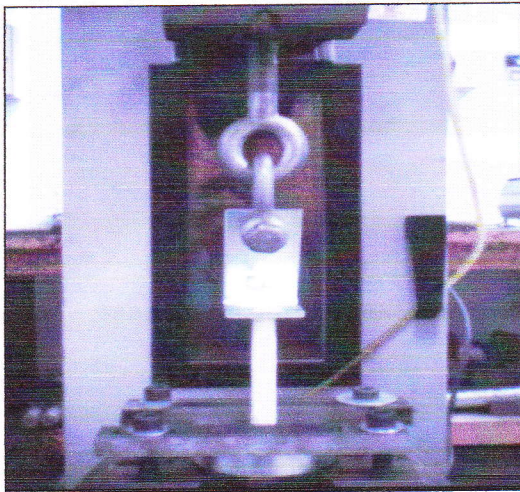
Photo 1.0 : Shows sample during test.

TEST SPEED : 5 mm/min

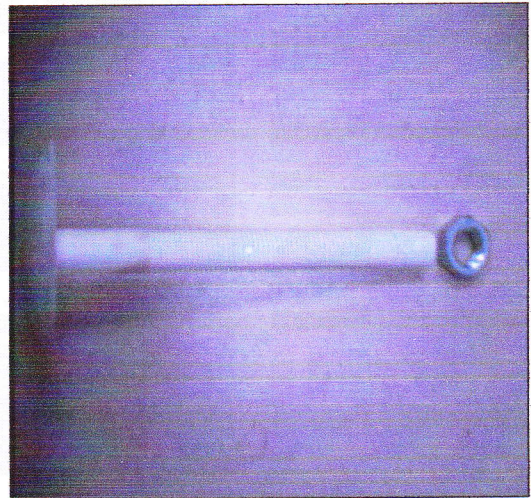
Photo 2.0 : Shows sample after test.

SAMPLE REFERENCE	BREAKING LOAD, (kN)	OBSERVATION / REMARKS
MTL Mushroom Bolt c/w Steel Bracket & Nut Serial No. : 80048	5.23	Bolt thread sheared
