## TEST REPORT

REPORT NO: 2008CB1317

MTL Heavy Duty (S/Steel Clad) Adjustable Foot Insert.

## **TEST RESULTS: COMPRESSION LOAD TEST**

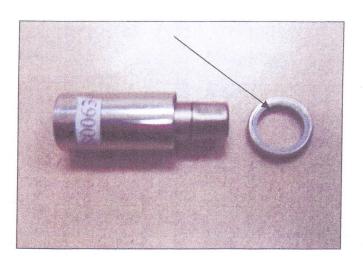
Photo 2.0: Show sample after test

SAMPLE REFERENCE	OBSERVATION / REMARKS
MTL Heavy Duty (S/Steel Clad) Adjustable Foot Insert	- Maximum load 32.10 kN load.
Serial No.: 80063	- The ring at the base fractured. (See photo 2.0)
