TEST REPORT

Product : MTL Durable PP (S/Steel Clad) Adjustable Foot Insert.

Reference Standard/
Method of test : Company's Specification : Compression Load Test .

TEST RESULTS : COMPRESSION LOAD TEST

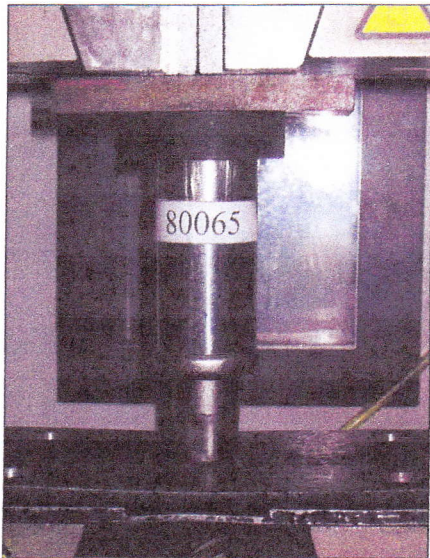
Photo 1.0 : Show sample during test

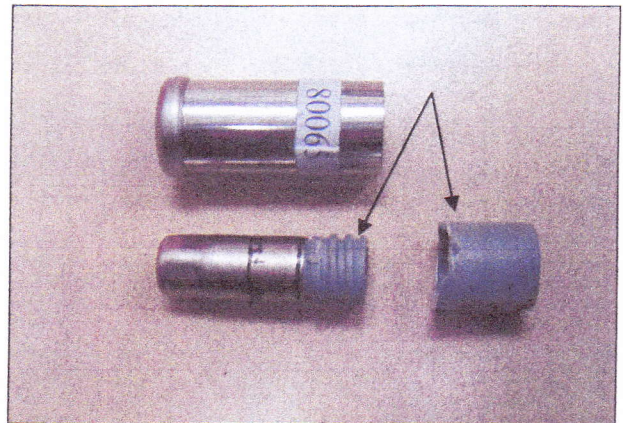
SAMPLE REFERENCE	OBSERVATION / REMARKS
MTL Durable PP (S/Steel Clad) Adjustable Foot Insert. Serial No.: 80065	<ul style="list-style-type: none">- Maximum load 6.68 kN load.- The Polyethylene Pipe (PP) fractured. (See photo 2.0)

Photo 2.0 : Show sample after test
